# Audit of the Public Buildings Service's Green Roof Maintenance and Safety Practices

Report Number A180085/P/4/R20008  
July 23, 2020

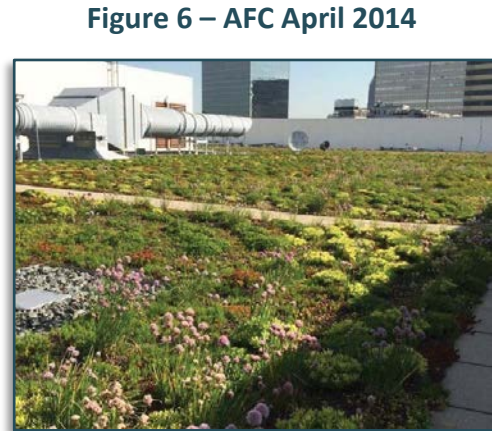
**Sam Nunn Atlanta Federal Center.** Located in Atlanta, Georgia, this Region 4 extensive green roof covers 63,188 square feet on two buildings at the Sam Nunn Atlanta Federal Center (AFC). PBS used \$2.7 million in Recovery Act funding for the design and construction of these roofs, which were completed in 2011. The roofs received 3 years of establishment period maintenance by a knowledgeable green roofing contractor. *Figure 6* shows the AFC green roof in April 2014, following establishment.

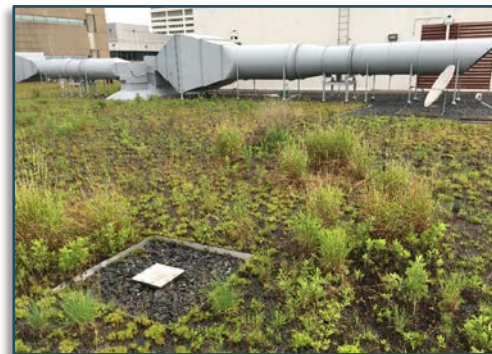
During a June 2018 interview, PBS Region 4 staff told us that they believed the roof was self-sustainable. For this reason, after establishment, they did not perform maintenance of the roof. *Figure 7* shows the roof after more than 4 years of neglected maintenance.

According to the establishment period maintenance contractor, annual assessments were provided from 2015 to 2017 to update PBS on the roof's diminishing health. The environmental horticulturist who completed the 2017 assessment identified the following issues resulting from neglected maintenance:

- Eighty percent of the original installed plant community had been choked out by weeds and lack of regular maintenance. The remaining intended plants will not thrive because available nutrients in the growing media are being used by the weed community.
- The lack of maintenance in the form of weed removal for several years has created a landscape condition referred to as “a long term four season weed seed bank.”<sup>4</sup> Unchecked, these roofs will be inundated with weeds for the balance of the serviceable life of the roof.

- The degree of the stated problem conditions is considered by this inspector to be “harmful and critical.” Immediate action should be taken to remove all weeds and debris in order to eliminate any possible fire hazard. Beyond this immediate action, a long-term effort is required if it is the desire of GSA to reap the cost savings and environmental benefits intended from the original design of these roofs.

The 2017 assessment included a quote for over \$120,000 for “a future replanting and maintenance effort to regain a minimum 80% plant density coverage.” It also included a \$19,775 quote for an immediate weeding effort to address the fire hazard. Instead, PBS awarded a \$22,916 contract to the building’s O&M contractor to address only the immediate weeding effort.

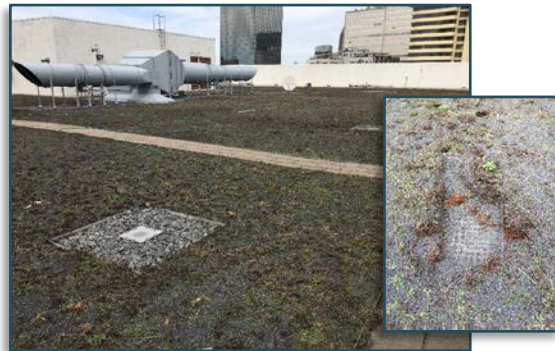
**Figure 8 – AFC February 2019**

The O&M contractor informed us that it subcontracted the work to a landscape contractor. While conducting the weeding effort, the subcontractor removed large sections of soil, exposing the green roof elements below (*Figure 8 inset*). The subcontractor also failed to clear drains of debris and plant life, potentially causing further damage to the green roof.

Upon completion, PBS staff approved the work and paid the O&M contractor the full contract amount. The February 2019 photo in *Figure 8* shows the results of the weeding effort. The O&M contractor told us that it had only expended \$1,990 to subcontract work to landscapers; resulting in a \$20,926 markup. In September 2019, we conducted a follow-up visit to assess the roof’s current state. *Figure 9* shows the roof now re-covered in weeds.

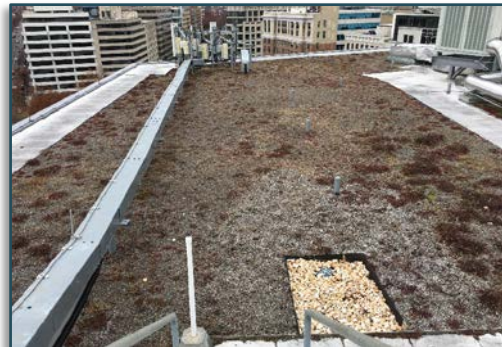
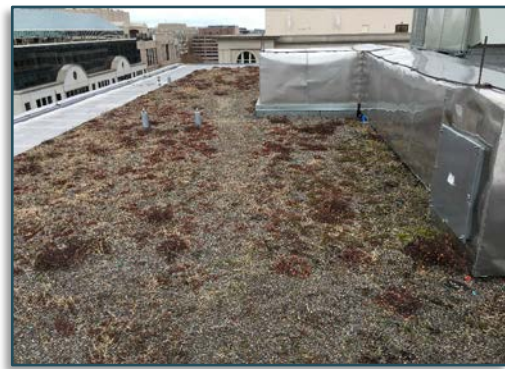
**Figure 10 – Lafayette Building  
December 2018**

During our December 2018 site visit, we noted areas of bare soil, debris, plant growth outside of intended areas, and plant growth near drain areas. *Figure 10* shows two sections of the 12th floor green roof exhibiting plant loss. This roof meets the 2011 GSA Study definition of wholesale failure and will require re-plantings and restoration efforts in order to perform at the level for which it was designed. PBS staff told us that they use a maintenance log to track when maintenance was performed; however, they did not respond to our request to provide this documentation.

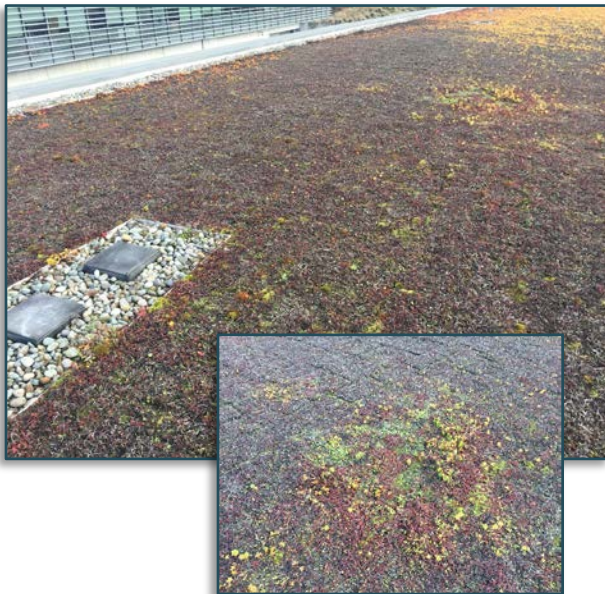
**Figure 11 – Peace Arch Land Port of Entry  
November 2018**

**Peace Arch Land Port of Entry.** Located in Blaine, Washington, this 22,000 square foot extensive roof in Region 10 was installed in 2009 for an estimated \$642,400. In 2012, the roof was replaced for an additional \$299,704. We visited the roof in November 2018 and observed areas of bare soil and plants that appeared wilted and yellow as shown in *Figure 11*. PBS Region 10 staff attributed this to an infestation of fly larvae that feed on the roots of the roof's vegetation. In order to eradicate this infestation, a chemical insecticide was used on the green roof. However, ASTM 2400-06 states that insecticides should be used sparingly because they could potentially hasten degradation of the roof membrane.

PBS staff said the roof receives monthly maintenance under a grounds landscaping contract, adding that maintenance is also tracked by PBS on a shared internal spreadsheet. We made multiple requests for contract documents and the tracking spreadsheet; however, PBS failed to respond.

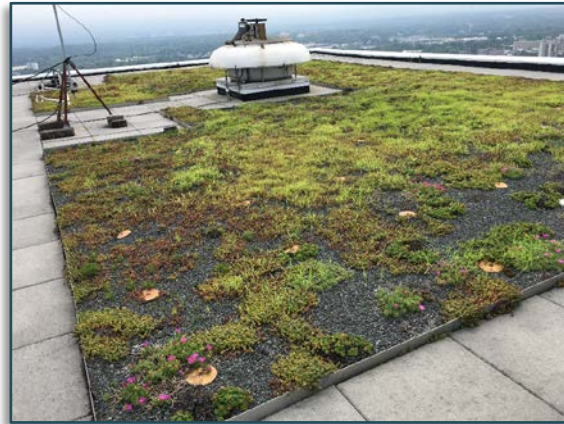
**Figure 12 – Peachtree Summit Federal Building  
June 2018**

Figure 12 shows the Peachtree Summit Federal Building's 2,800 square foot extensive green roof. Located in Atlanta, Georgia, this Region 4 green roof was completed in 2011 with \$235,000 of Recovery Act funding. PBS Region 4 staff stated that they were unaware that the green roof required maintenance or of any maintenance activities ever being conducted on this roof. Years of neglected maintenance has resulted in areas of bare soil, lost intended plant life, and weed growth.

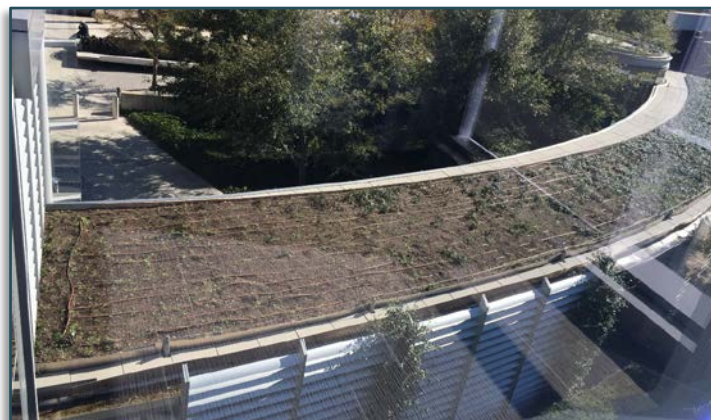
**Figure 13 – G.T. Leland Federal Building  
December 2018**

According to PBS staff, the O&M contractor damaged the roof's irrigation system while performing maintenance on the green roof in 2017, resulting in the death of the green roof. The O&M contractor then replanted the roof in Spring/Summer 2018 at its own expense of approximately \$20,000. PBS staff concluded that the roof now leaks because the contractor did not know what it was doing. Figure 13 shows that the green roof continued to exhibit plant loss in December 2018, after the replanting.

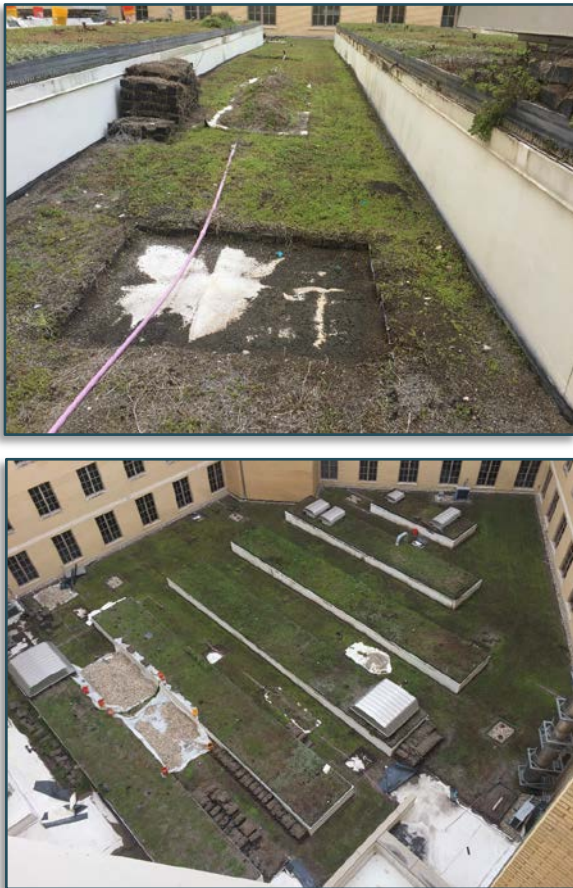
**Figure 14 – Hipolito F. Garcia U.S. Courthouse  
December 2018**

**Hipolito F. Garcia U.S. Courthouse.** In 2012, this 15,312 square foot extensive green roof in Region 7 was completed at the Hipolito F. Garcia U.S. Courthouse in San Antonio, Texas, using \$1.3 million of Recovery Act funding. According to PBS Region 7 staff, who had received no green roof training, maintenance for the green roof is occurring under the current O&M contract; however, the contractor has no specific knowledge of green roofs. The O&M contract does not specify green roof requirements or frequency of maintenance. Instead, maintenance is conducted on an “as-needed” basis. PBS provided documentation supporting that maintenance occurs only after issues are observed.

Six months after installation, leaks were discovered on the 1st floor of the building and have been pervasive ever since. In order to determine the root cause of these leaks, PBS Region 7 ordered two studies, one in 2016 and one in 2018, totaling more than \$46,000.

Although maintenance was not identified as the sole cause of the leaks, certain findings in the two studies support that proper maintenance could have prevented further damage. For example, the 2018 study found that drainage channels under the green roof trays were filled with growing medium, which prevented water flow to the drains. This issue should have been identified sooner had preventative maintenance been conducted in accordance with the 2012 PBS *Preventative Maintenance Guide* and industry standards.

Region 7 has decided to permanently remove all green roof elements above the waterproofing membrane in order to inspect, identify, and repair existing leaks. *Figure 14* shows the roof in December 2018.

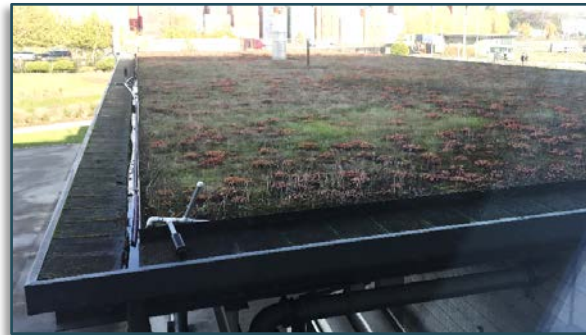
**Figure 15 – Seattle Federal Center South  
November 2018**

**Seattle Federal Center South.** This 2,800 square foot extensive roof in Region 10 was completed in 2012 at the Seattle Federal Center South in Seattle, Washington. PBS Region 10 staff told us they believed the roof was self-sustaining. Therefore, they had not maintained the roof since establishment. They added that the green roof had dried out, consisted of dead weeds, and had failed. *Figure 15* shows the green roof during our November 2018 site visit.

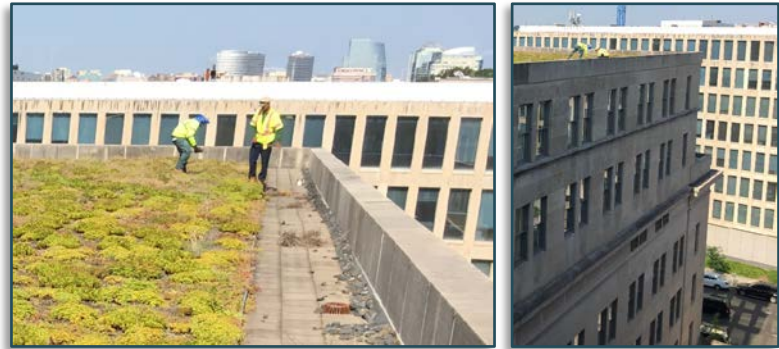
**Figure 17 – Stewart Lee Udall Department of the Interior Building July 2018**

**Exposure to Fall Hazards.** In 2012, 55,000 square feet of green roofs were completed on five wings of the Stewart Lee Udall Department of the Interior Building in Washington, D.C. A 2013 green roof safety assessment identified safety-related conditions on all five wings due to inadequate fall protection. The assessment also recommended the installation of OSHA-compliant guardrails but none have been added as of December 2018.

During our July 2018 site visit, while accompanied by PBS Region 11 staff, we witnessed green roof maintenance workers near the edge of the 7-story building protected only by an 18-inch parapet (*Figure 17*). Despite witnessing the contractor in non-compliance, PBS made no effort to enforce its contract clause and maintenance workers were exposed to fall hazards.

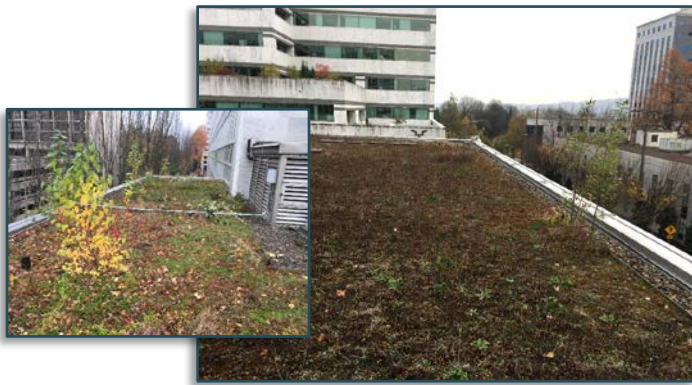
**Figure 18 – 911 Federal Building November 2018**

**Lack of Proper Maintenance.** In 2011, Region 10 completed a 12,150 square foot green roof at the 911 Federal Building in Portland, Oregon. As shown in *Figure 18*, the roof does not have a guardrail installed. According to PBS Region 10 staff, a maintenance contractor viewed the green roof in 2015 and stated it would not perform maintenance on the roof unless fall protection was provided.

PBS staff told us that they have plans to install a fall protection system on the roof and will commence green roof maintenance once installed. However, due to the prolonged period of neglected maintenance, the roof currently meets the 2011 GSA Study definition of a wholesale failure. *Figure 18* shows the roof in November 2018.
