# Audit of the Public Buildings Service's Green Roof Maintenance and Safety Practices

Report Number A180085/P/4/R20008  
July 23, 2020

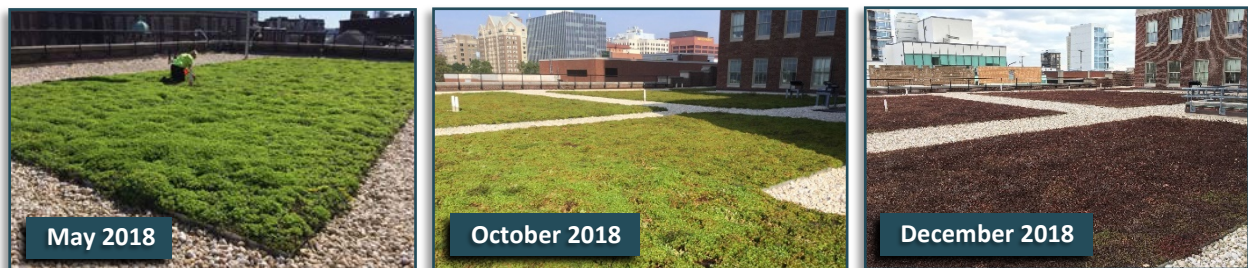
**Figure 3 – U.S. Custom House Green Roof Seasonal Photographs**

**U.S. Custom House.** Completed in 2012, this Region 3 extensive green roof covers 22,000 square feet of this building in Philadelphia, Pennsylvania. PBS Region 3 contracts for ongoing maintenance with the building’s operations and maintenance (O&M) contractor who then subcontracts the work to a knowledgeable green roofing contractor. The roof receives six maintenance visits during the growing season (March through November) at an annual cost of \$6,634.92 (\$0.30 per square foot). The maintenance contractor provides inspection reports to the PBS building manager following each visit noting the health of the green roof, maintenance activities that were conducted, and potential issues requiring PBS’s attention. During our December 2018 site visit, we found that the green roof exhibited full plant coverage, was free of debris and trash, and drains were free of weed growth. The images in *Figure 3* show the U.S. Custom House green roof at different times of the year.

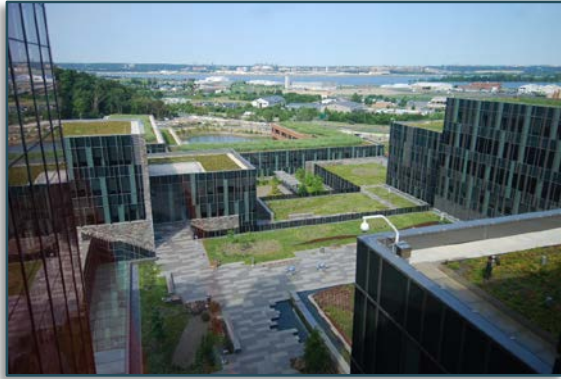
**Figure 4 – Douglas A. Munro  
Coast Guard Headquarters Building**

**Douglas A. Munro Coast Guard Headquarters Building.** Completed in 2013, this Region 11 green roof is the largest in PBS’s inventory. It consists of 557,000 square feet of extensive and intensive roofs covering multiple buildings at the St. Elizabeths Campus (see *Figure 4* on the following page) in Washington, D.C. Maintenance of the roofs is conducted by a landscaping contractor at an annual cost of \$198,300 (\$0.36 per square foot). In accordance with contract terms, these green roofs are weeded at least four times per year, soil is tested, fertilization is applied in response to test results, and dead plants are replaced. A PBS Region 11 horticulturist oversees the maintenance.

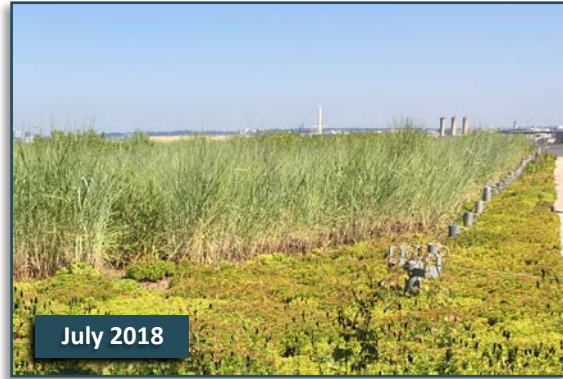
**Figure 5 – Douglas A. Munro  
Coast Guard Headquarters Building**

During our July 2018 site visit, we witnessed landscapers weeding the parking deck green roofs. Also during this visit and a subsequent December visit, we noted full plant coverage, roofs free of debris and trash, and drains that were free of weed growth (see *Figure 5*).
